**WSDOT/WASHINGTON STATE FERRIES**

**Investigation into the Circumstances Surrounding the  
Damage to the Propulsion Drive Motor aboard the  
M/V WALLA WALLA on Nov. 4, 2012 while  
Undergoing Maintenance at Eagle Harbor  
Maintenance Facility**

**2/25/2013**

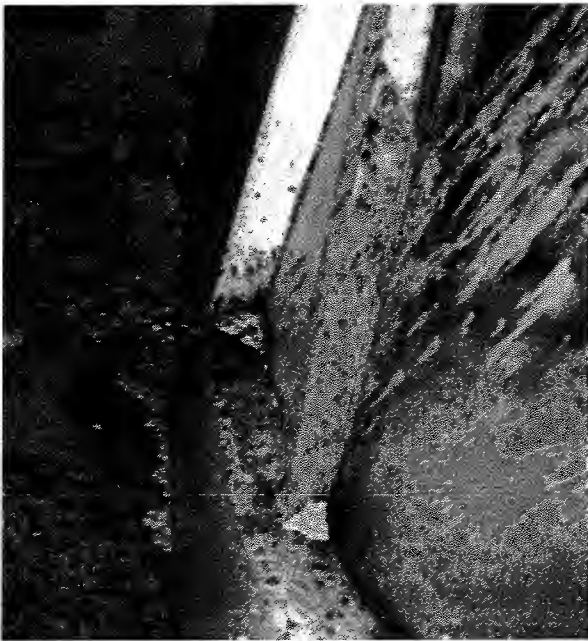
Molten and spattered copper from Commutator bars in Drive Motor housing

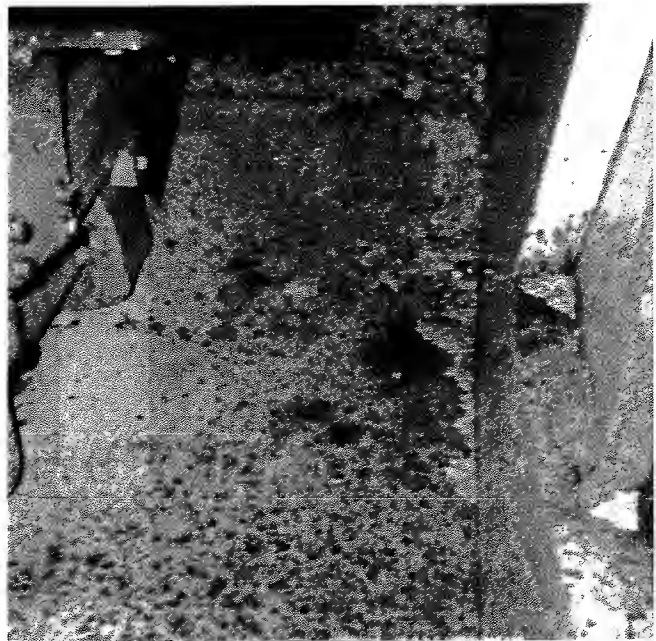
Molten and spattered copper from Commutator bars in Drive Motor housing

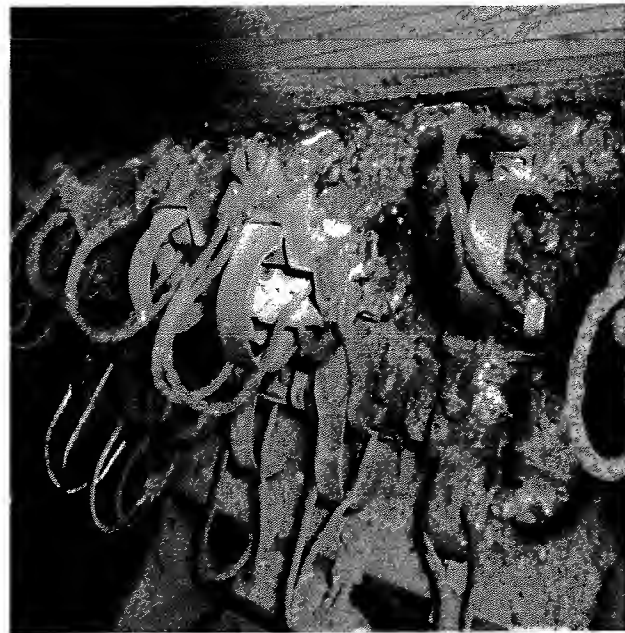
Damaged carbon brushes, brush pigtails, brush holders, and commutator bars

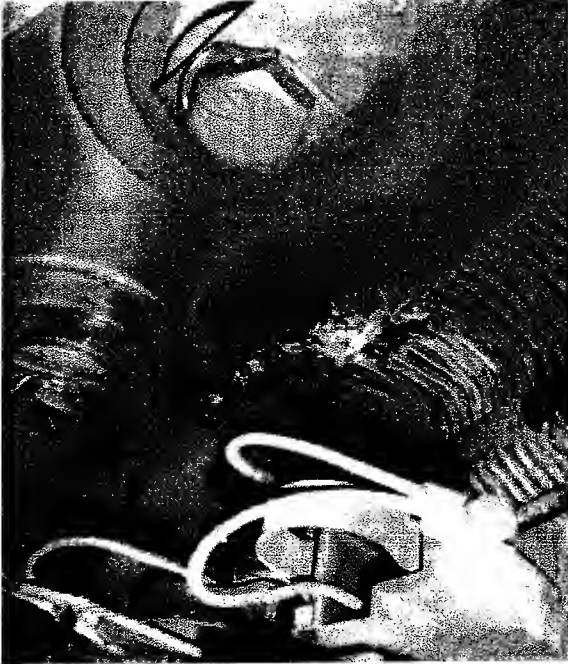
Burned commutator bar riser to winding connections

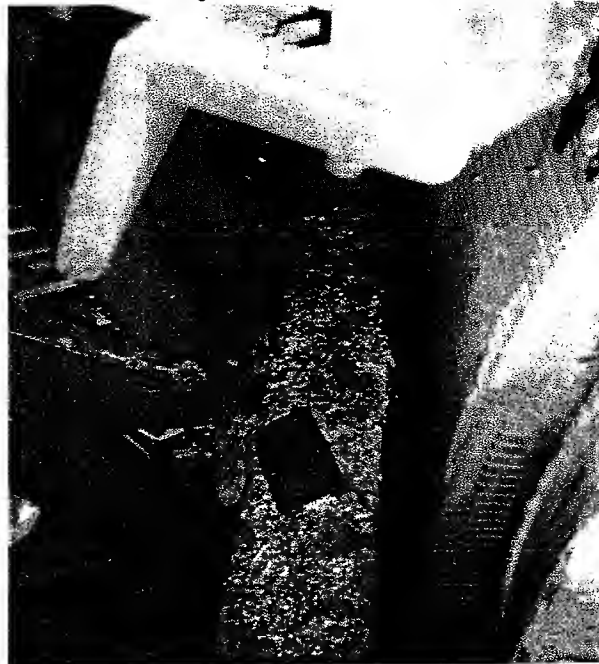
Molten copper on brush rigging

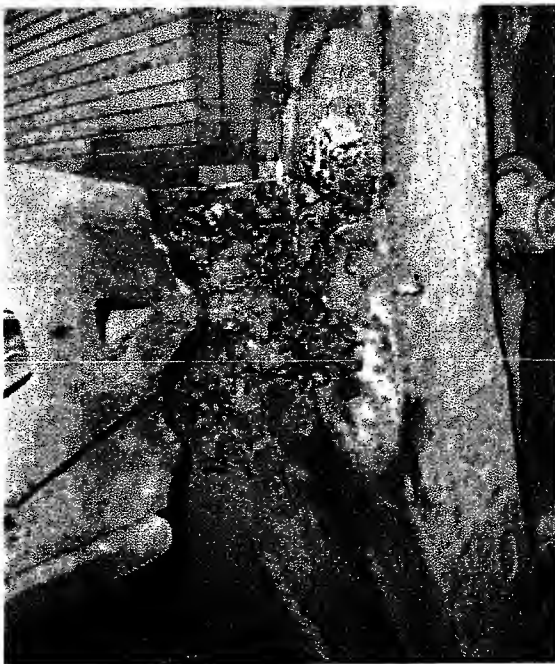
Extensive damage to brush and commutator bars

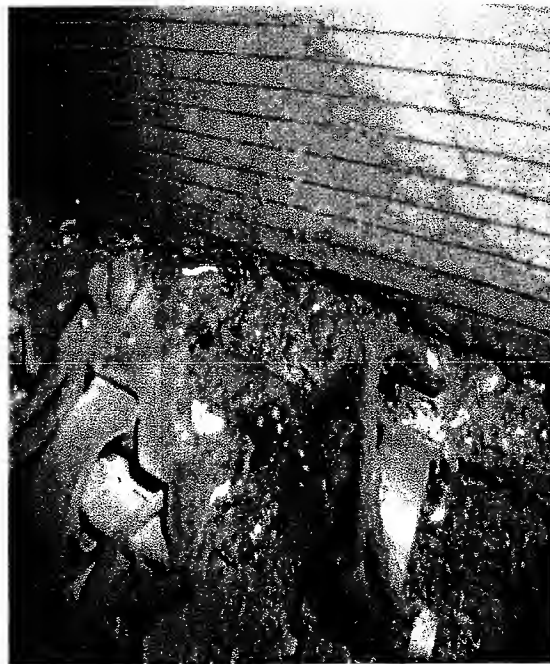
Extensive damage to brush and commutator bar

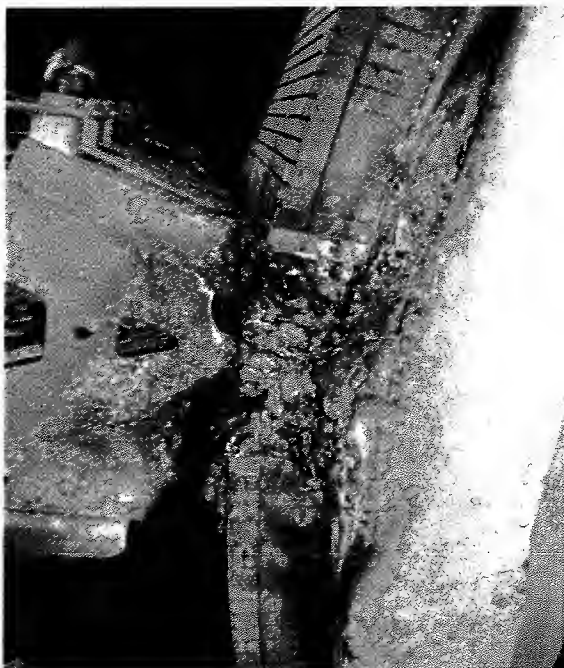
End on view of extensive damage to brush and commutator bars

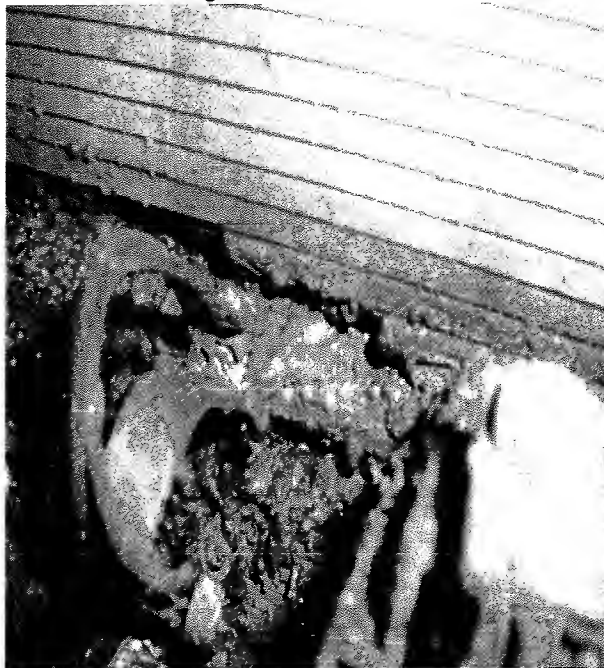
Extensive damage to brush and commutator bars

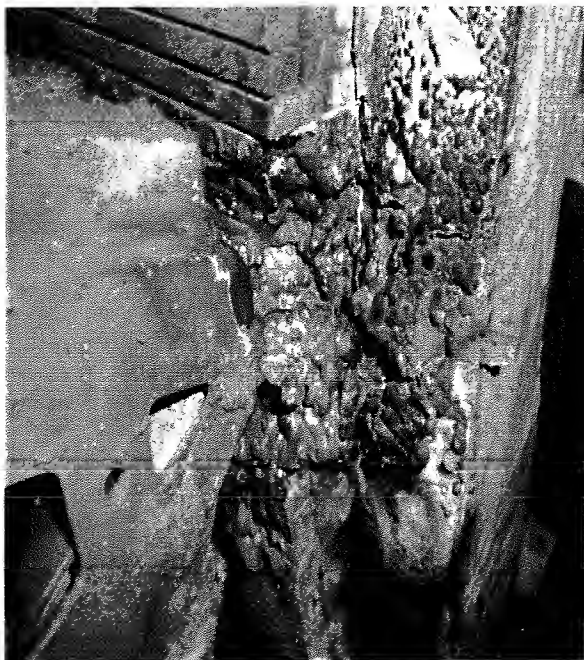
Extensive damage to brush and commutator bars

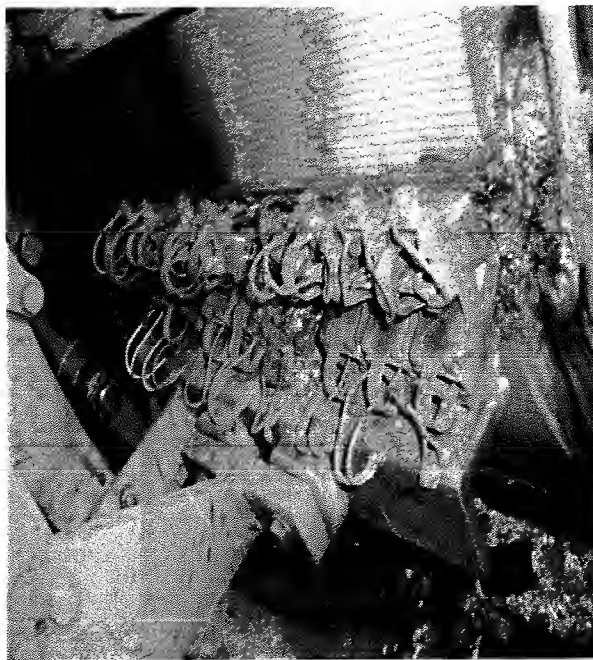
Overall view of the row of brushes that overheated arced, and caused the extensive damage to brush and commutator bars

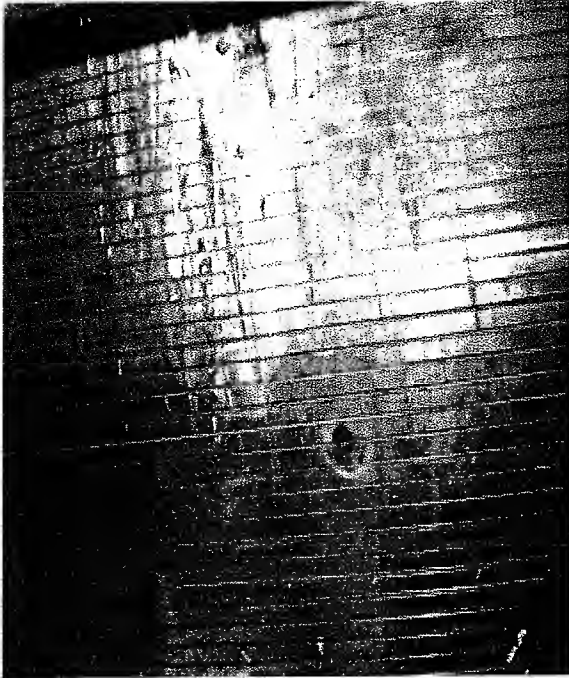
Commutator bars adjacent to the severely damaged area, showing signs of spattered, molten copper

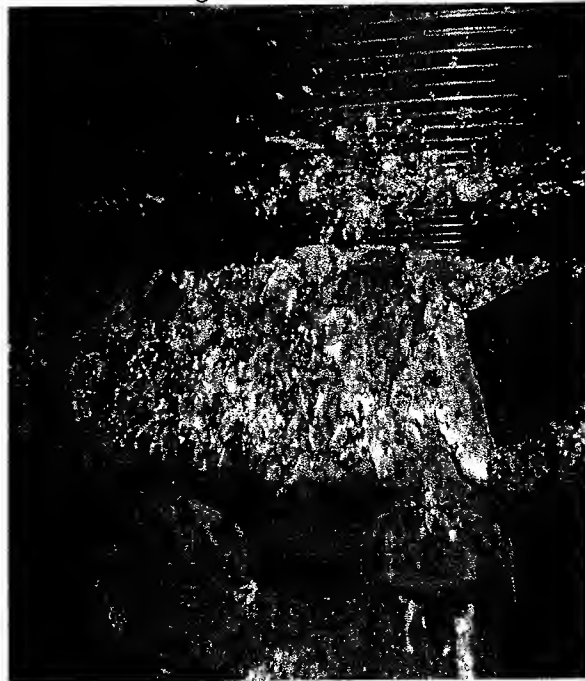
Molten and spattered copper on brush rigging and commutator bars

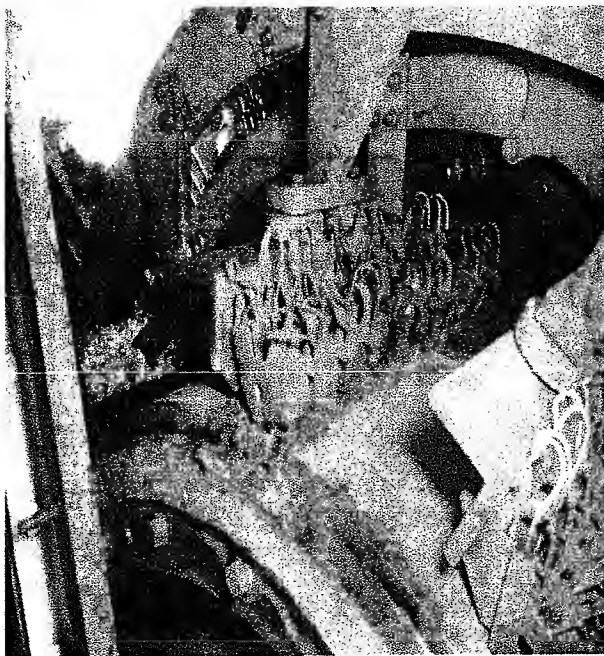
Overall view of the row of brushes that overheated and caused the extensive damage to brush and commutator bars

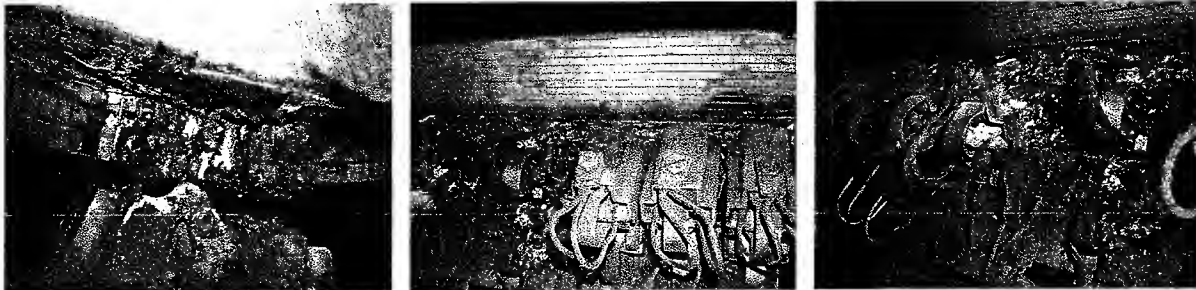
Figures 1-3

On November 4, 2012, the vessel Walla Walla was moored at Eagle Harbor Maintenance facility, undergoing propulsion system maintenance. The 1A propulsion motor suffered severe overheating and damage to its armature (see Figures 1, 2, and 3). This incident happened due to a breakdown in communication between the maintenance crew and vessel engineers, lack of system understanding and written procedures and an overly ambitious schedule, attempting to accomplish more than reasonably possible.

The 1A motor was scheduled to have maintenance done after the 2B stoning procedure was completed. Because two sets of brushes were left in their operational position, voltage was applied to the armature through the brushes while the A propulsion loop was energized and caused significant heat damage.

The Plexiglas covers were all in place on the 1A motor during this incident, containing all arcing that occurred. Because the covers were in place, it eliminated any safety concerns regarding adjacent equipment or personnel. There were no individuals in that space during this maintenance.

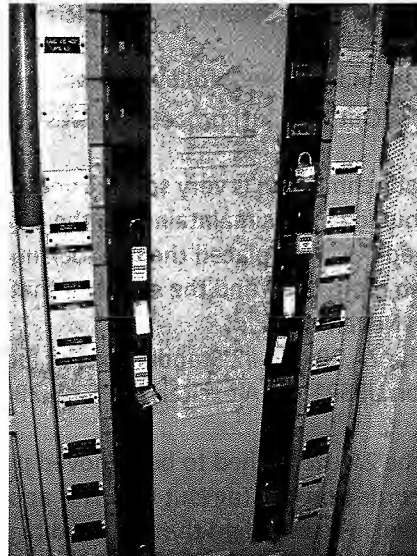
**Figure 3**

The Staff Chief Engineer, Bruce Cooper, opened all the switches for the 1A & 1B motor exciters, tagged and locked out the power to the exciter cabinets for the 1A & 1B motors; see Figure 3.

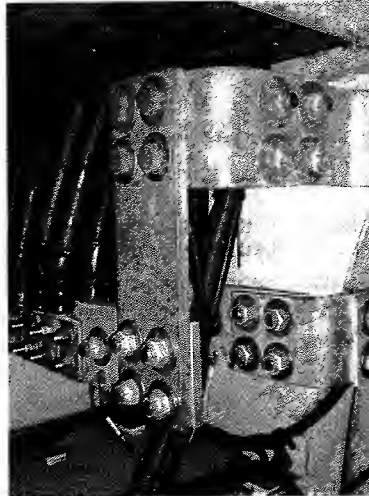
**Figure 4**

Figure 4 shows the links that are located in an enclosure which is attached to each motor. If a motor has to be isolated completely from the energized propulsion loop, these links must be removed and repositioned so that the loop stays closed, going around the motor circuit and isolating the motor armature from the loop voltage.
